Name Of Dam: GREGORY'S POND DAM
Location: CHESTERFIELD COUNTY
Inventory Number: VA. 04122

PHASE I INSPECTION REPORT

GREGORY'S POND DAM
CHESTERFIELD COUNTY, VIRGINIA
INVENTORY NO. 04122

Deward M. Martin & Associates, Inc.
August 1979

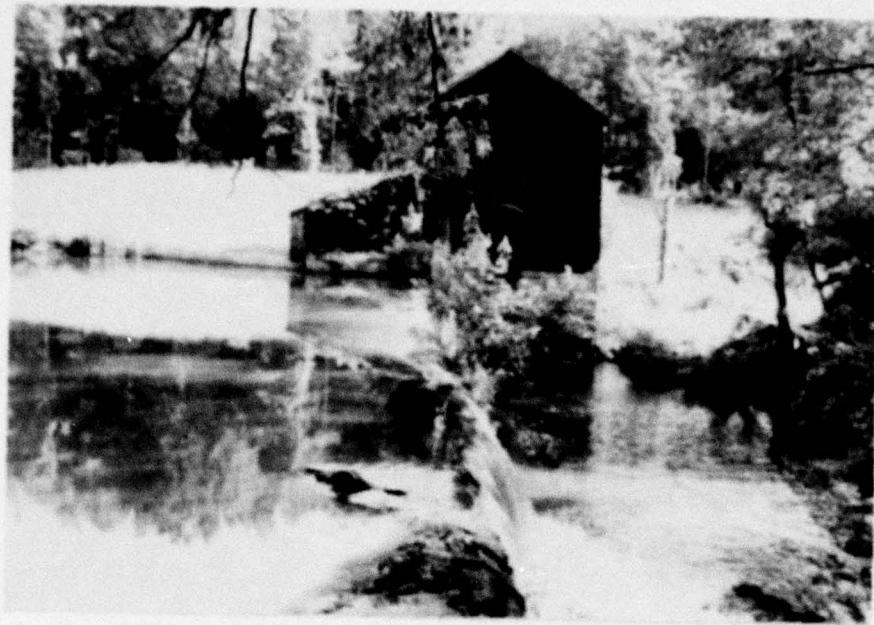
Overview of Dam

VISUAL EXAMINATION OF	OBSERVATIONS	REMARKS OR RECOMMENDATIONS
SURFACE CRACKS CONCRETE SURFACES	N/A	
STRUCTURAL CRACKING	N/A	
VERTICAL AND HORIZONTAL ALIGNMENT	Small displacements on both vertical and horizontal alignment.	See photographs, overview of dam on page 111 and No.'s 1 & 2.
MONOLITH JOINTS	N/A	
CONSTRUCTION JOINTS	None observed.

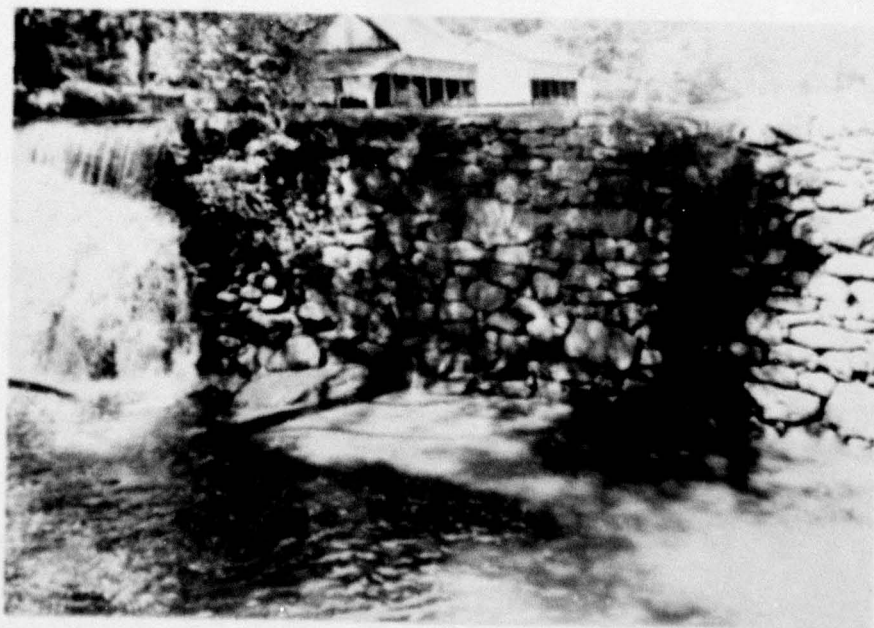
Downstream Face

VISUAL EXAMINATION OF	OBSERVATIONS	REMARKS OR RECOMMENDATIONS
SEE PAGE ON LEAKAGE	Leaks at bottom in the mill house wall and in front of the dam where natural rock ends at tailwater.	See page iii, Downstream face picture for the natural rock and leakage.
STRUCTURE TO ABUTMENT/EMBANKMENT JUNCTIONS	No obvious settlement, no erosion visible.	
DRAINS	No drains were observed during the inspection.	
WATER PASSAGES	None.	
FOUNDATION	Masonry gravity type foundation

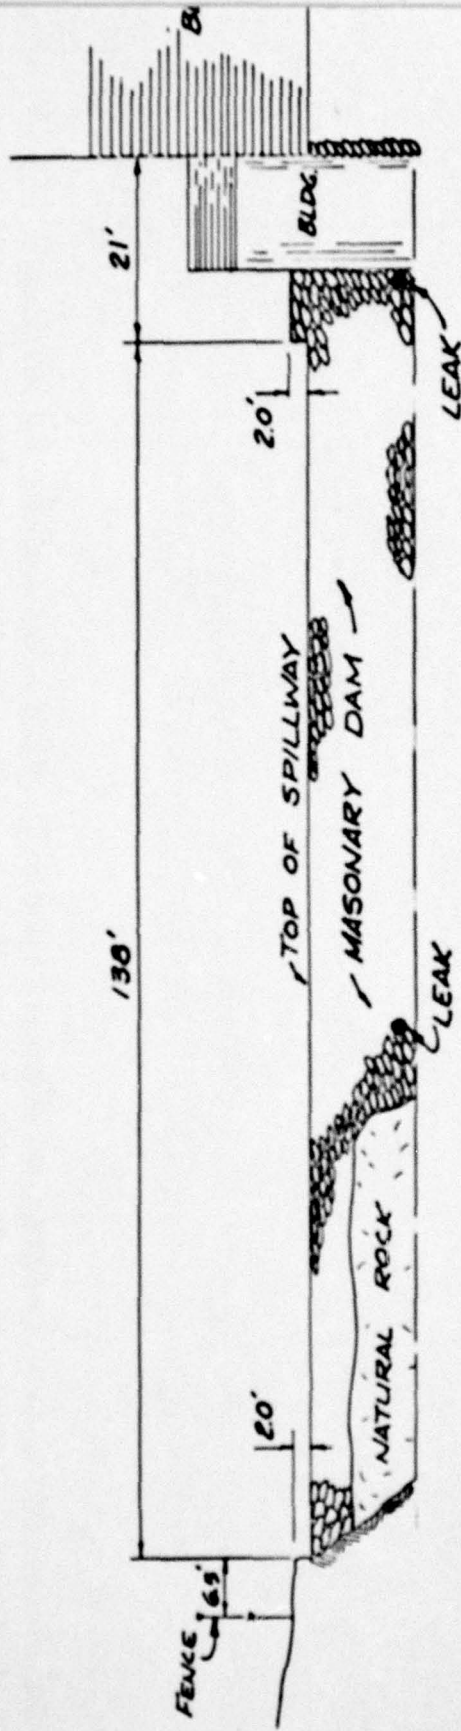
GREGORY POND DAM
 SCALE : 1" = 20'
 PLATE NO. 1

The dam is constructed of large rocks laid without mortar. On the upstream face of the dam there is parging from the crest down to the base of the dam. (See sketch on Plate 1, Appendix I.)

*Seepage was observed at several locations through the dam. Two sizable leaks were observed, each estimated to be more than 10 gallons per minute. The first leak was located near the base of the dam just left of the rock outcropping to the right side of the dam. A second sizable leak was observed at the left abutment near the dam's contact with the mill. (See Plate No. 1, Appendix I). The leaks did not reflect any noticeable deterioration in the dam.

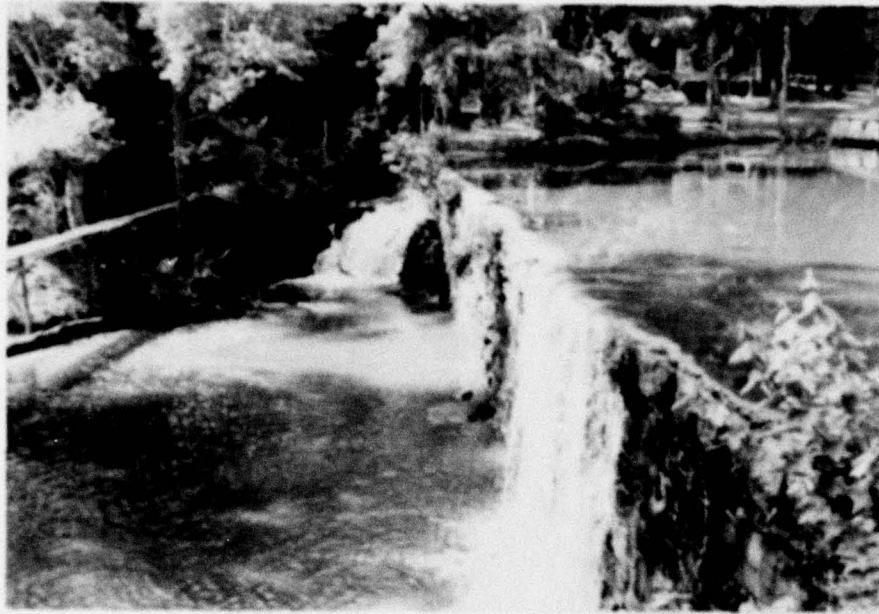
PHOTOGRAPH NO. 1
Dam and Pond

3.1.4 Spillway: This spillway is a masonry structure 138 feet long with a crest elevation of 167.0 feet. There appeared to be a slight bulge in the spillway (about 1 foot) midway along the crest (see Appendix II, Photographs 1, 2 and 4.)

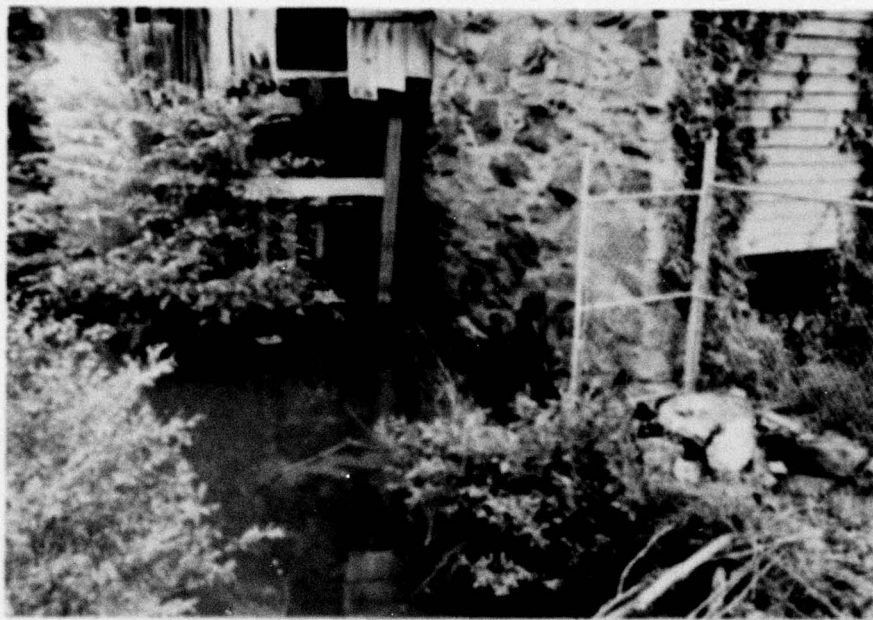
PHOTOGRAPH NO. 5
2-foot x 2-foot Box Culvert

3.1.3 Appurtenant Structures: There is a 2-foot x 2-foot concrete box culvert located at the base of the mill house which can be used to drain the pond. This culvert can be opened by a manually operated slide gate which is inside the mill. Both the gate and the culvert seem to be in good condition.

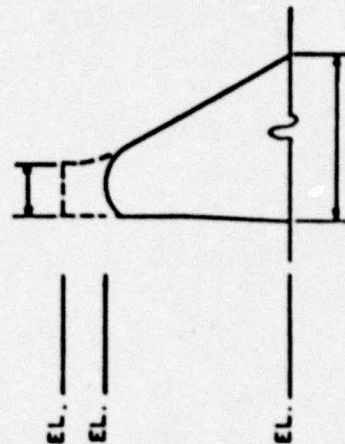
PARTIAL SECTION

LOADING CASE	ELEV. HEAD WATER	ELEV. TAIL WATER	ΣV	ΣH	$\frac{\Sigma H}{\Sigma V}$	LOCATION RESULTANT FROM TOE	% BASE COMPRESSION IN	FACTOR SAFETY SLIDING	FOUNDATION PRESSURE	
									TOE	HEEL
NORMAL POOL	167	155	10.08 ^k	4.5 ^k	0.45	4'			1.7	--
100-YEAR FLOOD	173.5	167	8.0 ^k	6.2 ^k	0.78	4'			1.3	--

THIS ANALYSIS IS BASED ON THE ASSUMED GEOMETRIC CONFIGURATION SINCE NO DRAWINGS WERE AVAILABLE TO VERIFY THE DIMENSIONS OF THE DAM.
